MISCELLANEOUS PAPER SL-80-6

**CONCRETE AND ROCK TESTS, MAJOR
REHABILITATION OF STARVED ROCK LOCK AND
DAM, ILLINOIS WATERWAY, CHICAGO DISTRICT
PHASE II COMPLIANCE, SCOUR DETECTION**

April 1980

Final Report

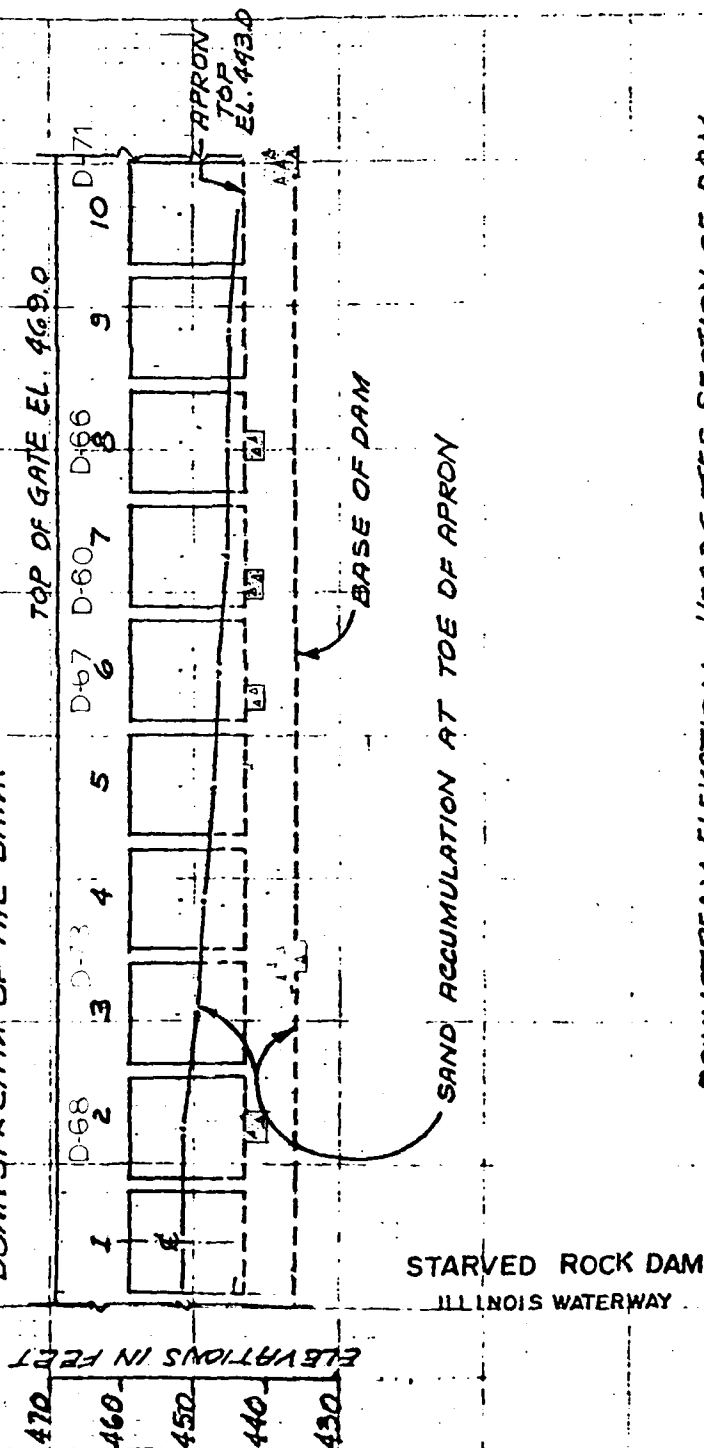
Figure 7. Scouring at face apron - head gates 1-10

Figure 6 shows the scouring at the face of the apron in the taintor gate dam as plotted by NCC. Superimposed on this graph are the actual base elevations of concrete at boring locations given in the above tabulation. Figures 7, 8, and 9 show the scouring at the apron face in the head gate dam. These figures illustrate the base elevation of the concrete as

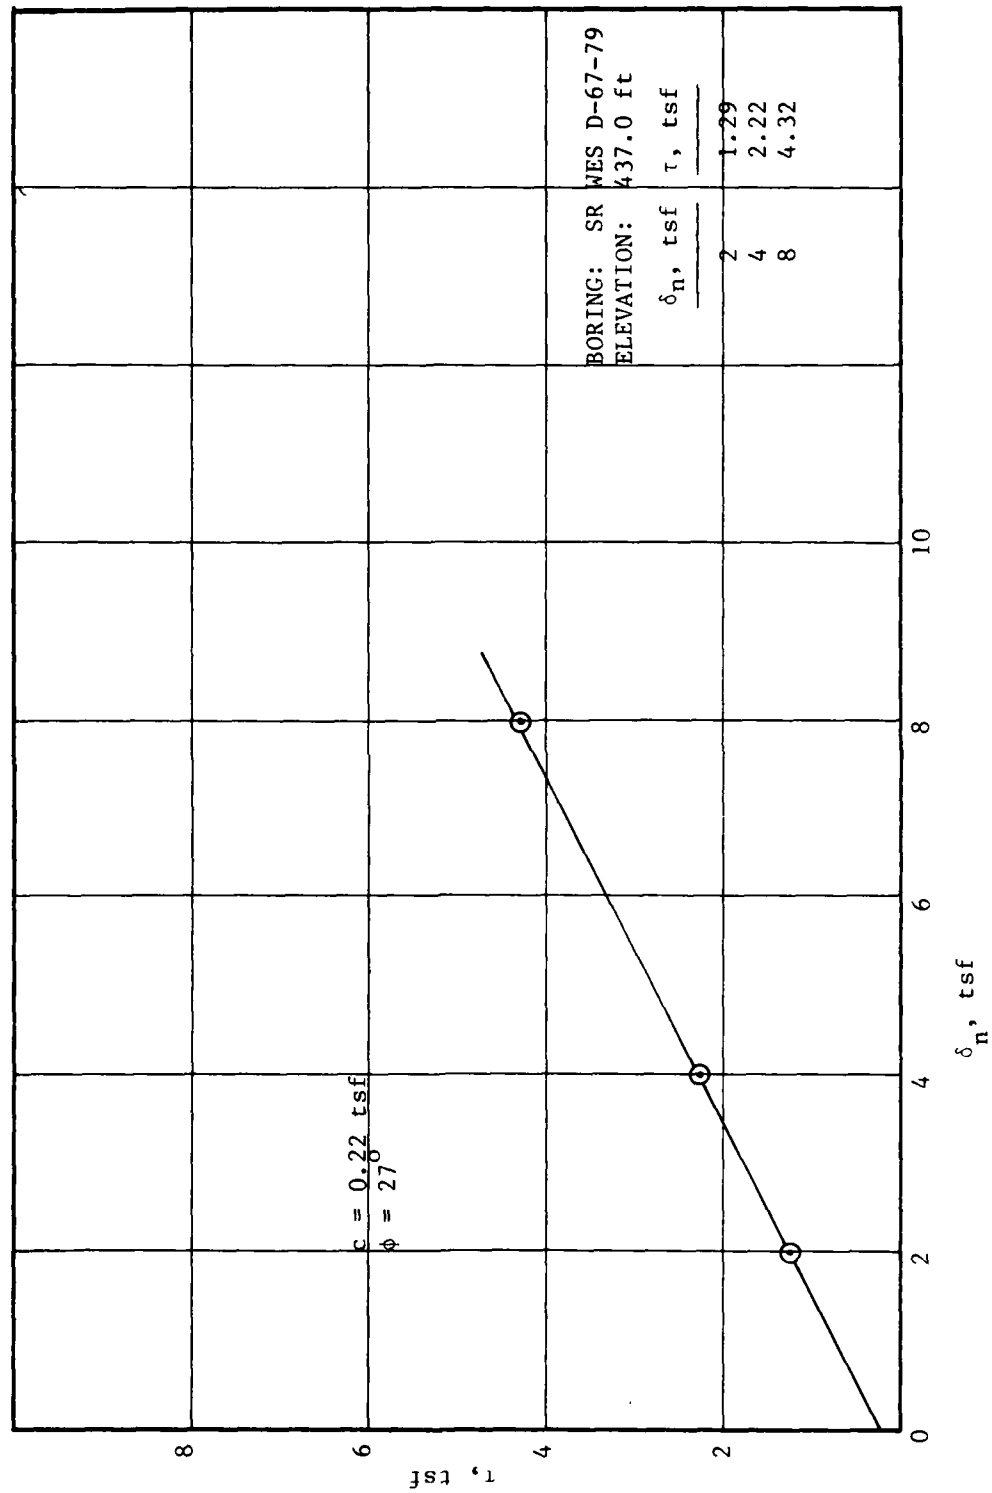
Plate 22. Direct shear of silty sand (SM), head gate dam

67. The sample was classified as a silty sand (SM). A direct shear box (1 by 3 by 3 in.), used for testing soils, was used to run direct shear tests on the sand. The normal loads used were 2, 4, and 8 tsf. A plot of the normal load versus shearing load is presented in Plate 22. The angle of friction for the sand is 27 deg with a cohesion is 0.22 tsf.

103. One possible weak zone beneath the head gate dam is the weakly cemented silty sand found directly below the concrete in bays 1 through 13. The shear strength values for the silty sand are $\phi = 27$ deg and $c = 0.22$ tsf. A second possible weak zone is the shale seam found directly beneath pier 16. A $\phi = 11.9$ deg and $c = 3.7$ tsf is recommended when this zone is considered in the stability analysis.
